Sampling of a Solid Mass Adjacent to an Implant in a Reconstructed Breast

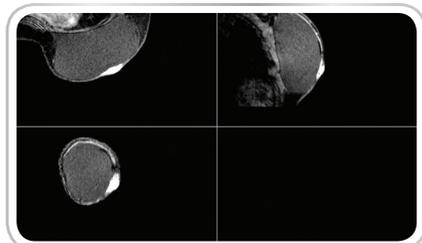
FIG. 1.1

MRI: Contrast enhanced MRI of the breasts shows a uniformly enhancing (plateau dynamic curve) oval mass at the 4 o'clock position, resting along the margins of the implant and measuring 3.5cm x 1.5cm x 1cm (FIG. 1.1) (FIG. 1.2).

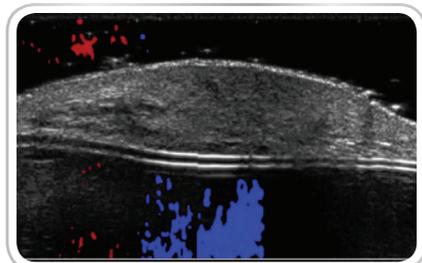
FIG. 1.3

U/S: Second look ultrasound confirms the presence of an isoechoic, relatively avascular solid lesion, corresponding to the MRI and palpable finding (FIG. 1.3).

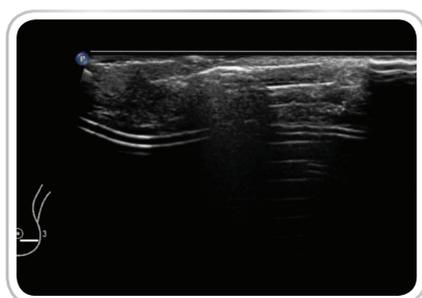
FIG. 1.4

Local anesthesia was carefully introduced into the skin, subdermal tissue and into the targeted mass under sonographic guidance. A skin nick was carefully created, the tip of the scalpel almost reaching the margin of the implant. Under ultrasound control, a 13-gauge Mammotome elite biopsy device probe was inserted into the mass. Samples were acquired with the trough aperture directed in four different directions (FIG. 1.4).

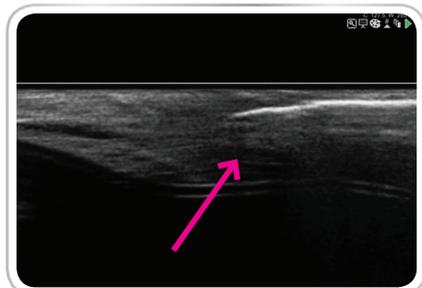
FIG. 1.5

After the samples were obtained, a petite HydroMARK biopsy clip was introduced into the mass within the biopsy cavity (FIG. 1.5).
