## Diagnosis Sampling and Management of a Fibroadenoma

### Clinical Situation

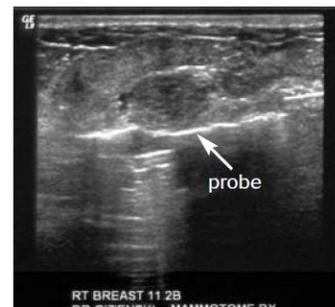
*Figure 3* Probe insertion

After instilling a buffered general anesthetic to the lesion and surrounding tissue, a longer acting anesthetic was also administered to provide additional pain relief. A 20G spinal needle was used for anesthesia administration to help provide a path for the Mammotome® probe. This ensures easy insertion of the probe, while the technologist is applying backpressure to the patient's breast (*Figure 3*). Samples were taken of the lesion until it was no longer visible by ultrasound imaging (*Figure 4*). The patient experienced no bleeding during the biopsy procedure. A MammoMARK™ clip was placed at the biopsy site in the event the biopsy showed a phyllodes tumor (*Figure 5*). A post biopsy mammogram shows the clip to be at the site of the previously seen nodule. A small hematoma developed as we performed the post biopsy mammogram (*Figure 6*). A post biopsy specimen x-ray was obtained to show the lesion in present in the samples that were obtained (*Figure 7*).

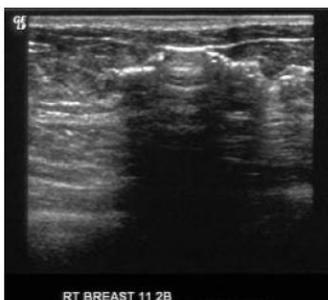
*Figure 4* Lesion no longer visible

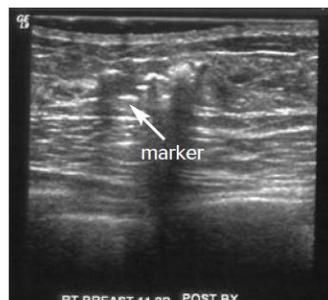
*Figure 5* Marking the biopsy
