Diagnosis Sampling of an Indeterminate Lesion

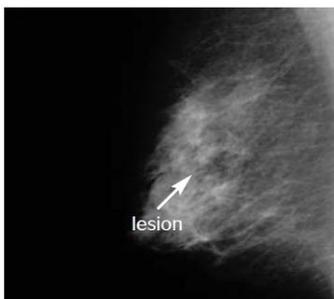
Figure 1a Lesion as seen on mammogram

The patient was a 70-year old female who presented for her screening mammogram. A new high density, speculated lesion was seen in the right breast at the 12 o'clock position on her mammogram (*Figure 1A and B*). The ultrasound images show an irregular, hypoechoic mass at the 12 1B position in the right breast, 1cm from the patient's nipple (*Figure 2*). The overall dimensions of the lesion are 13 x 12 x 13mm. The lesion is highly suspicious for a malignancy; therefore a biopsy using an 8G Mammotome® probe was performed.

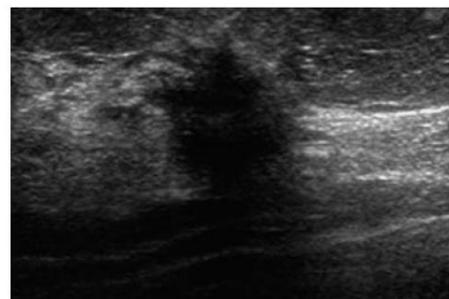
Figure 2 Lesion as seen on ultrasound

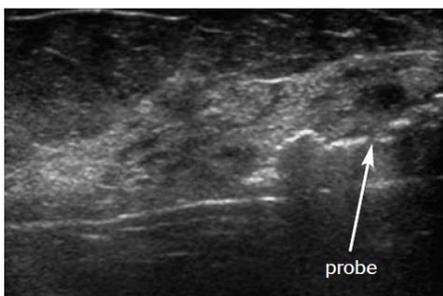
Figure 3 Probe insertion

Under ultrasound guidance, the lesion was localized. A buffered general anesthetic was used to bathe the lesion. Additionally a deeper anesthetic was used to provide extended pain relief. The anesthesia was introduced with multiple needle lengths to ensure the entire area surrounding the lesion was anesthetized. A 20G spinal needle was also used to help create a tract for the 8G Mammotome® probe to slide easily into position below the lesion (*Figure 3*). Twelve samples were obtained without difficulty. A marketing clip was subsequently placed in the region of the lesion. A post biopsy mammogram revealed the clip to be within the lesion (*Figure 4*). A specimen radiograph was also obtained to ensure the lesion was contained within multiple samples (*Figure 5*).
